Lisbon Water Pollution Control Authority
Regular Meeting
November 7, 2019, 7:00pm
Lisbon Town Hall

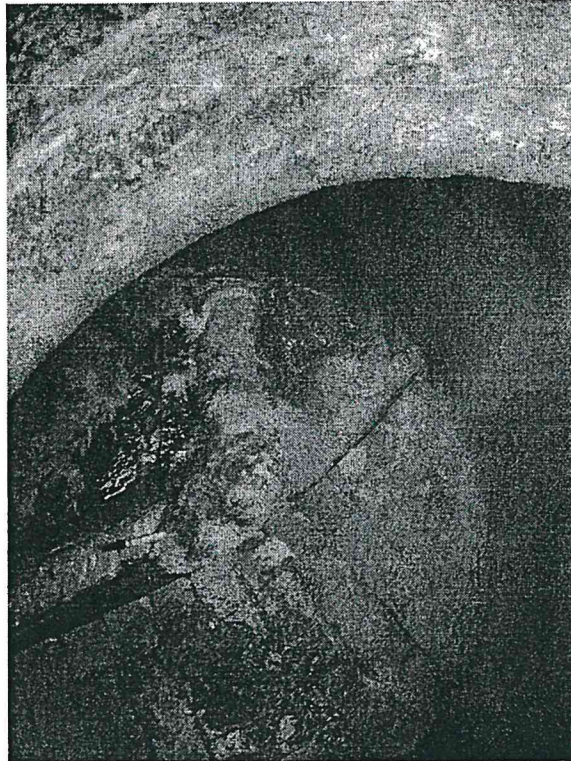
- **October 24, 2019**
 - o **Both grease trap tanks appeared to be operating correctly and appeared to have been regularly maintained.**
 - o **We opened the downstream manhole and observed a blockage on the bathroom waste line. There was a full pipe diameter wad of paper products extending all of the way to the center of the manhole that was blocking the invert (see photo below). It was not possible to determine what the wad of paper products was composed of. We had the employees flush the toilets and the flow was just barely bypassing the blockage. The manager was contacting a septic pumper to have the blockage removed.**

- **We met with the manager and spoke to him regarding lack of pumper's report being submitted.**
 - **The Manager stated that they run cold water into the system for 2 hours each night. It seemed as though the temperatures in the grease traps was cooler than previously observed.**
